Manhole Inspection Summary

Manhole # S17W__023MH

Insp Date: **6/24/08 1:12 PM**

Location Address: **1601 harman av**

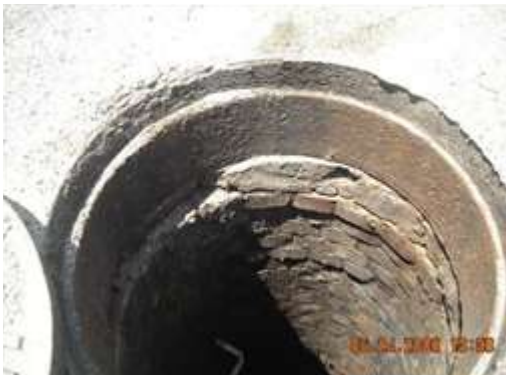
Misc

☐ Prev. Rehab Weather: **Dry** Subject To Ponding: **Sheeting**

inflow evidence from sheeting

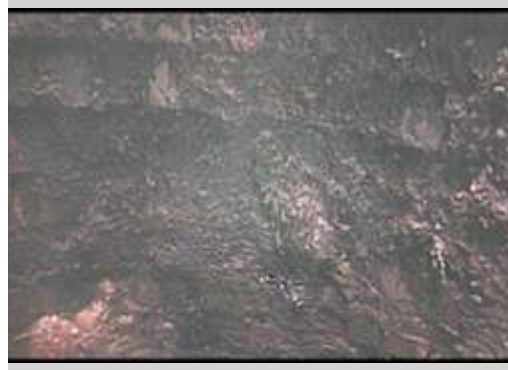
Defect 5

Condition: ☐ Sound ☐ Cracked ☐ Root Intrusion ☐ Loose Brick ☒ **Deteriorated**

deteriorated barrel wall

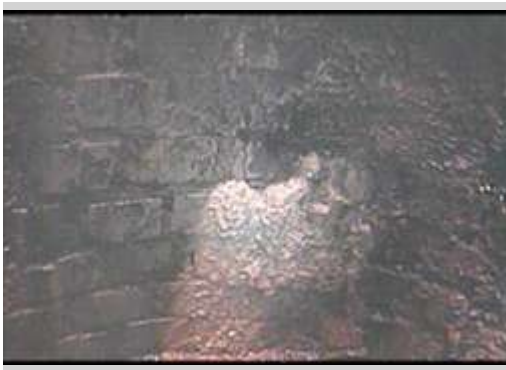
Defect 4

Infiltration: ☐ None ☐ Joint ☐ Cracks ☐ Mortar ☐ Roots ☒ **Wall**

infiltration @ barrel wall

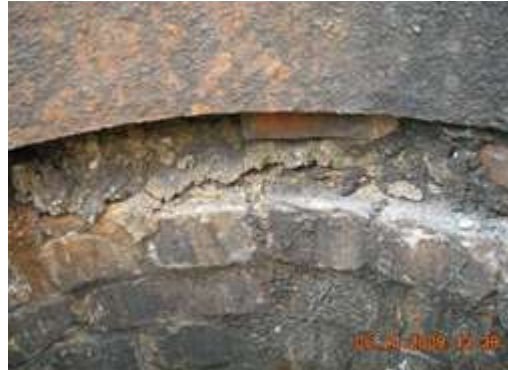
Defect 3

Condition: ☐ Sound ☐ Cracked ☐ Root Intrusion ☐ Loose Brick ☒ **Deteriorated**

deteriorated chimney

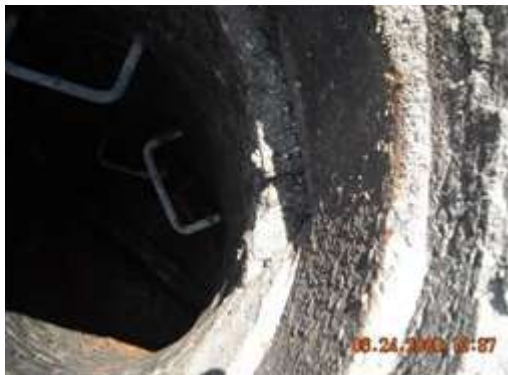
Defect 1

Frame Offset: **1** (in.) Condition: ☒ Sound ☐ Cracked ☐ Leaks

frame offset

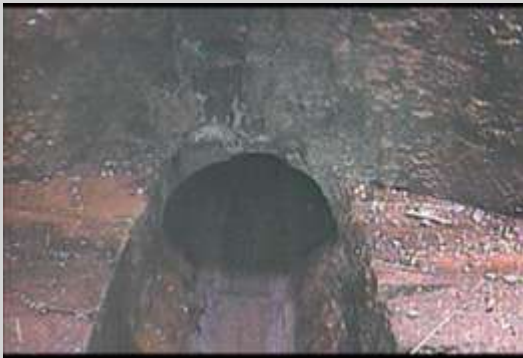
12 O'Clock Outflow

Pipe Height: **8.4** (in.) Rod and Bar (Angled)
Pipe Material: **Clay** ☐ Pipe Lined
Invert Depth: **10.54** (ft.) Flow Characteristics: **Slow**
Deposits: ☒ None ☐ Mud ☐ Sludge ☐ Debris ☐ Grease
Silt Depth: **0** (in.) Deposits Extent:
Infiltration: **Evidence** Pipe Seal Cond: **Cracked**
